TARGETED MOLD & MOISTURE ASSESSMENT REPORT

Residential / Dormitory Buildings

5800 Bay Shore Road
Sarasota, Florida 34243

May 22, 2023
Partner Project No. 23-401745.1

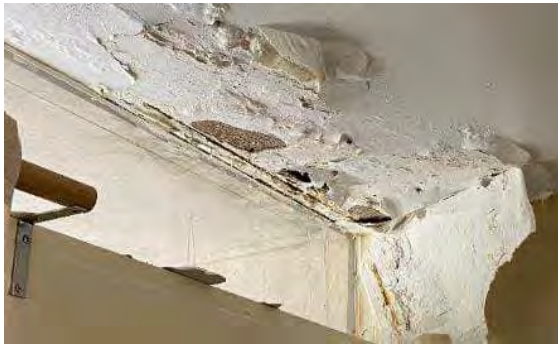
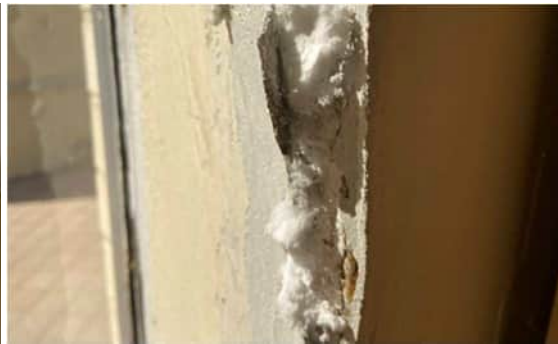
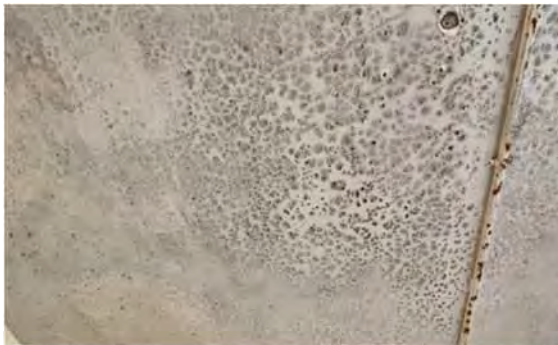
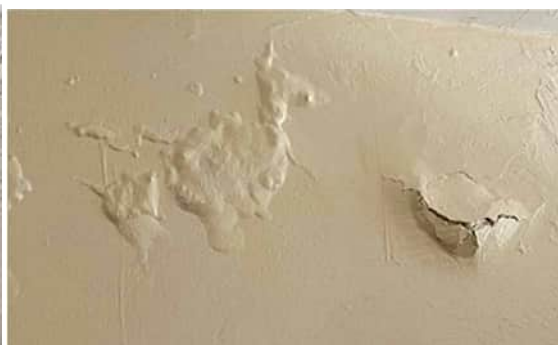
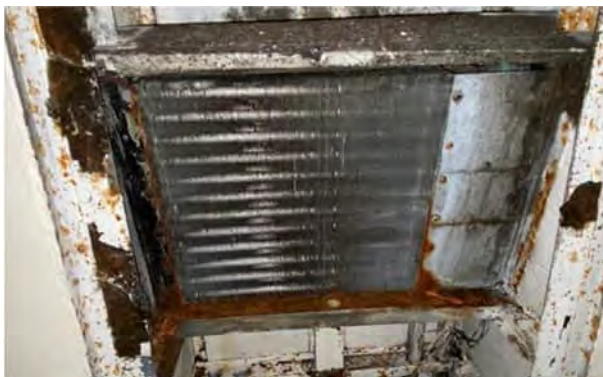
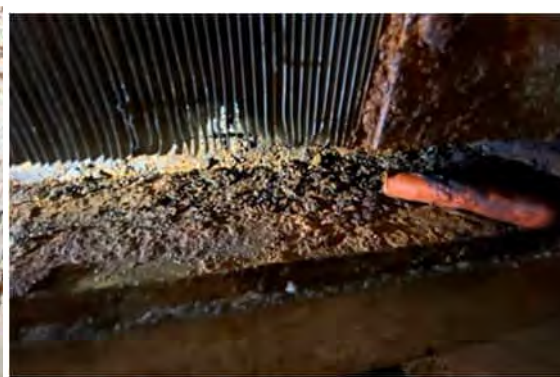
Building PEI 1

- **PEI Buildings 1, 2 & 3** - The majority of the offline units assessed in the 3 buildings revealed evidence of systematic moisture damage around windows adjacent to ceilings and walls, moisture intrusion through cracking in cast-in-place concrete ceiling decks, efflorescence damage on ceilings and walls, water-damaged floor tiles, delaminating from substrate, SVM on ceilings and walls, and dusty/dirty/rusted HVAC units with Suspect Visible Mold. The air handlers in the units may be original and not functioning effectively or efficiently due to the observed conditions. A walk-around observation of the building exteriors revealed cracking in exterior brick façade on bricks and mortar, spalling concrete on building walls, balconies and stairs, and damaged floor tile & grout on balconies. The occupied units assessed in PEI 3 revealed similar circumstances, however at less of a scale.

- Suspect Visible Mold on ceilings and walls
- Heavy dust load and Suspect Visible Mold on HVAC vents.
- Moisture damaged ceiling and wall building materials
- Efflorescence damaged ceiling and wall building materials
- Moisture intrusion through cracks in cast-in-place concrete ceiling decks
- Dusty/dirty/rusted HVAC units with Suspect Visible Mold
- Building materials were “dry” in units assessed

- ❖ These buildings should not be occupied in their current condition. A fiscal investment is required to conduct an envelope evaluation, complete the exterior and interior structural damage repair and renovation and the changeout of HVAC systems to replace current HVAC systems.

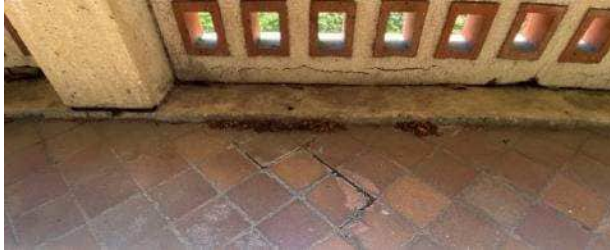
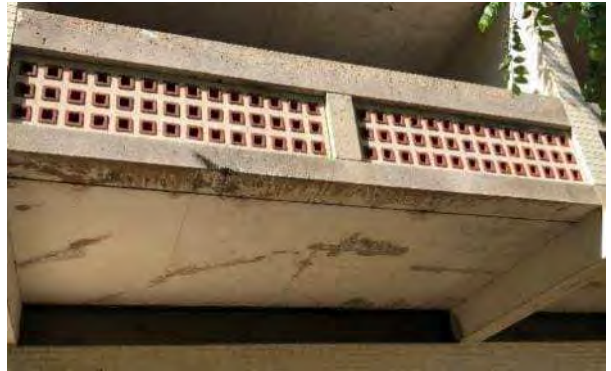
Building 1 PEI 1 Exterior

- Cracked exterior brick façade – Brick and Mortar
- Spalling concrete – Building walls, balconies, stairs
- Damaged tile & grout on balconies

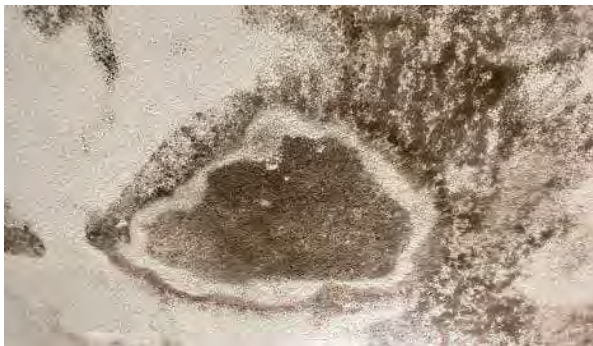
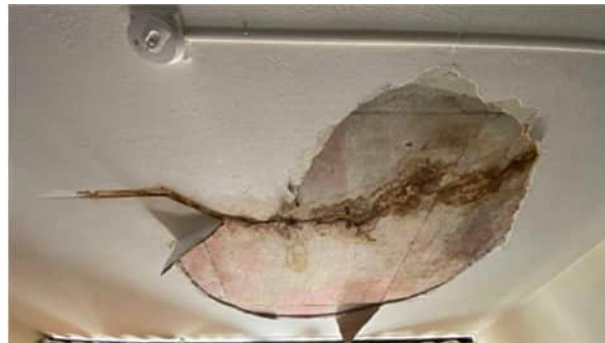
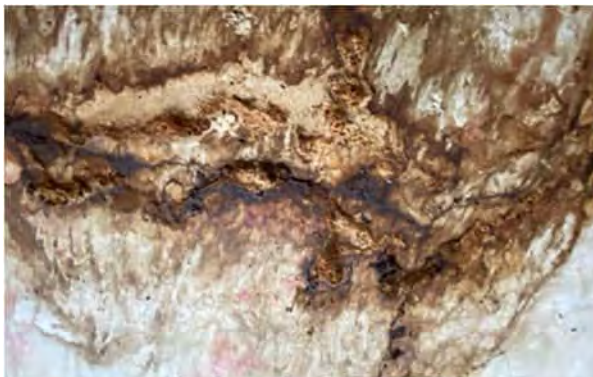
Building PEI 2

- Suspect Visible Mold on ceilings and walls
- Heavy dust load and Suspect Visible Mold on HVAC vents.
- Moisture damaged ceiling and wall building materials
- Efflorescence on damaged ceiling and wall building materials
- Potential moisture intrusion through cracking in cast-in-place concrete ceiling decks
 - Unit 247
- Dusty/dirty/rusted HVAC units with Suspect Visible Mold
- Water-damaged floor tiles, delaminating from substrate
- **“Wet”** building materials were identified in the following units included in our assessment
 - Unit 247 – Ceiling in shower
 - Unit 246 – Wall

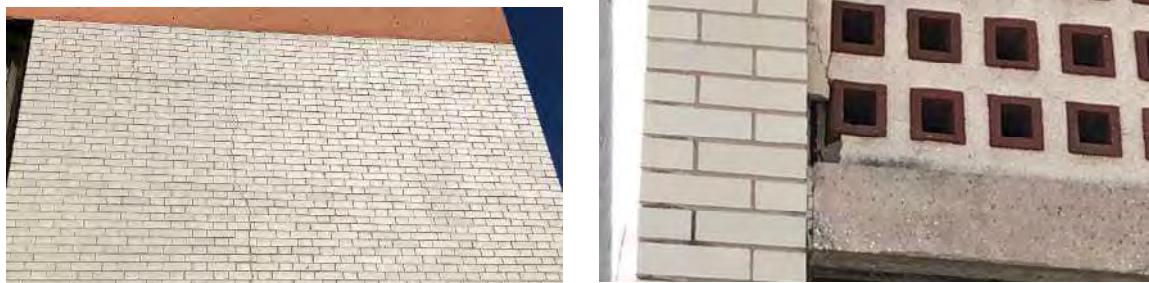
Building PEI 2 Exterior

- Cracked exterior brick façade – Bricks and Mortar
- Spalling concrete – Building walls, balconies, stairs
- Damaged floor tile & grout on balconies

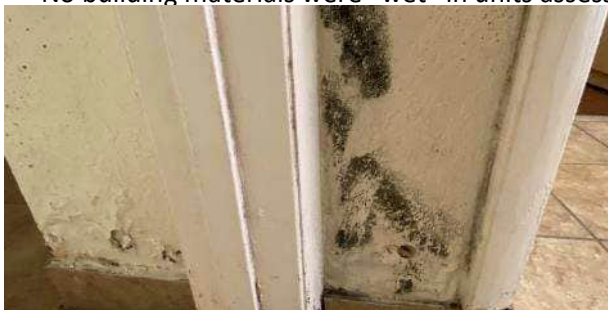
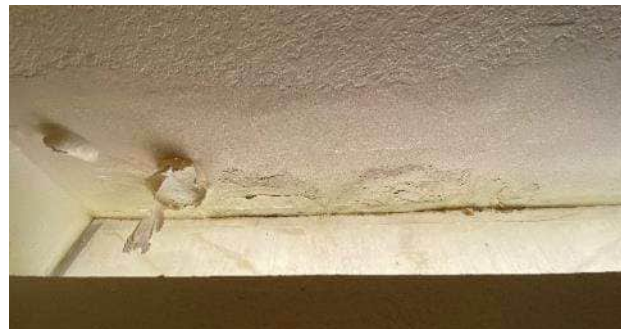
Unoccupied Units:

- Suspect Visible Mold on ceilings and walls
- Heavy dust load and Suspect Visible Mold on HVAC vents.
- Moisture damaged ceiling and wall building materials
- Efflorescence on damaged walls and ceiling building materials
- Dusty/dirty/rusted HVAC units with Suspect Visible Mold
- Water-damaged floor tile, delaminating from substrate
- No building materials were “wet” in units assessed

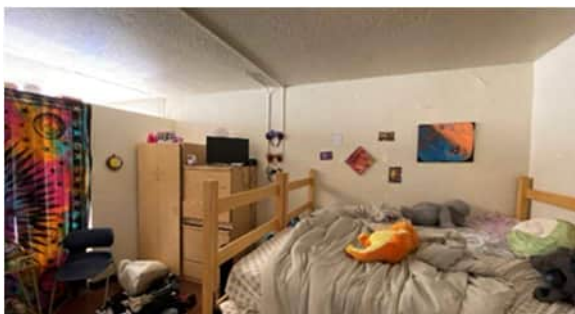
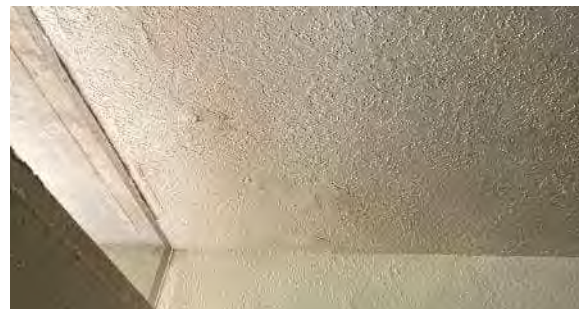
Occupied Units:

- Suspect Visible Mold on ceilings and walls
- Heavy dust load and Suspect Visible Mold on HVAC vents
- Moisture damaged ceiling and wall building materials
- Efflorescence on damaged ceiling and wall building materials (see above)
- Dusty/dirty/rusted HVAC units with Suspect Visible Mold
- No building materials were “wet” in units assessed
- Damaged tile & grout on balconies

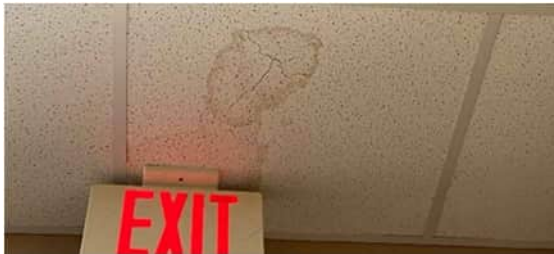
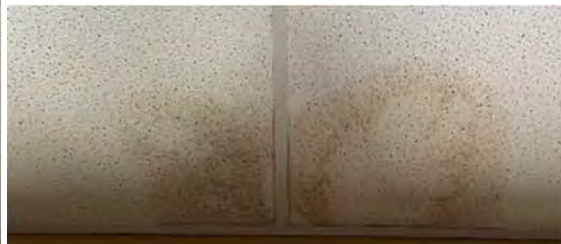
Common Areas:

- Water-stained ceiling tiles

- ❖ Remove and replace moisture-stained ceiling tiles. Inspect nearby HVAC metal vent and ducts for condensation/sweating or plumbing failures or roof leaks. Use of rubber seal between metal vents/diffusers and ceiling material may minimize water/mold damage.
- ❖ Check ventilation and/or exhaust in restrooms for adequate flow of conditioned air and exhaust of moist air.
- ❖ A fiscal investment is required to conduct an envelope evaluation and complete exterior structural damage repair and interior renovations.

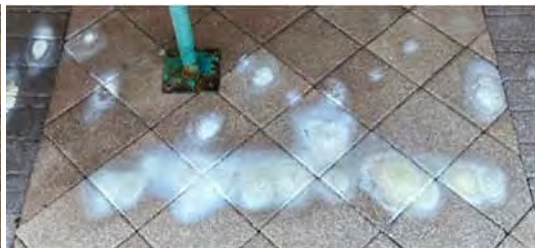
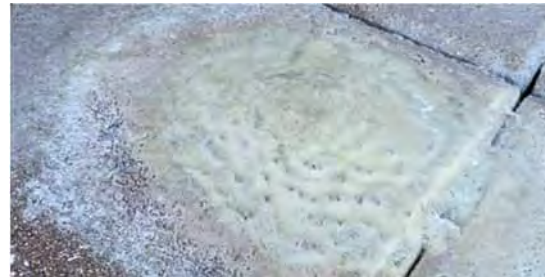
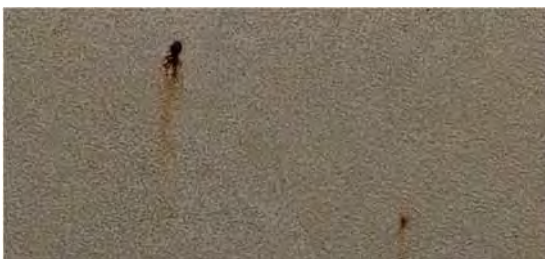
Exterior:

Building Z – Minimal moisture damage observed in the occupied areas such as suspect visible mold on ceilings in unit restrooms and moisture-stained ceiling tiles in the shared areas. The building’s exterior revealed cracking in the façade, and possible structural damage on a balcony overhang. Mineral leaching observed from overhead areas onto brick façade causing calcification deposits below occurs with constant available moisture. The rust spots observed permeating through the stucco exterior indicate moisture is penetrating through the stucco surface to corrode the metal below. The identified exterior deficiencies lead to significant interior building material and structural damage if not permanently addressed, as evident in this building with only temporary patching or repairs and painting.

- Mineral leaching from concrete onto brick façade and dripping onto sidewalk
- Structural damaged balcony overhang at 2nd floor South
- Rust permeating through stucco exterior.

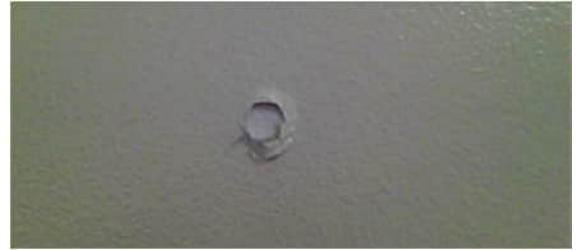
Occupied Units:

- Moisture damaged wall building materials
- No building materials were “wet” in units assessed

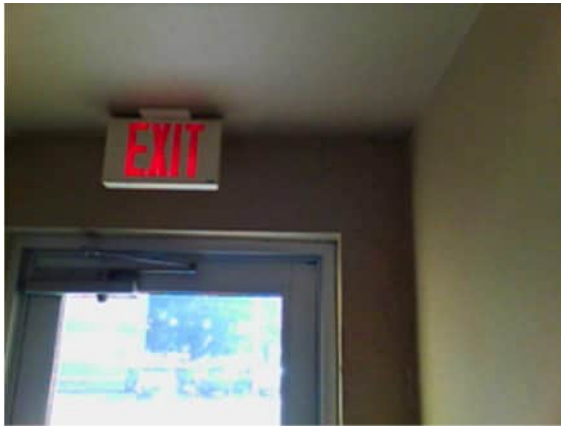
Building V Common Areas:

Buildings V, W, X & Y - Minimal to no moisture damage observed in the occupied areas. The moisture-stained ceilings and walls on the ground floor adjacent to the east exit doors is present in all four (4) buildings and may be a design defect, whereas the moisture-stained walls in shared areas adjacent to windows may be due to component (frame) seal failure. Moisture damage on drop-in ceiling panels within 1st floor shared area HVAC closets could be related to sweating HVAC ducts, plumbing failures or roof leaks.

- Moisture damaged building materials on perimeter wall near exit in 1st FL Common area
- Moisture damaged building materials on dropped ceiling of HVAC Closet in 1st FL Common area

- ❖ Evaluate the exit door area for a source or pathway for moisture intrusion and take appropriate corrective actions. Replace mold/water damaged building materials once corrective action is completed. Leaving water damaged building materials in place is not recommended due to the fact that mold, even though not visible, is present/dormant and will become active again quickly.
- ❖ Remove water damaged ceiling panels in HVAC closets and inspect duct work and plumbing above, as well as roofing for source of moisture intrusion and water damage. Replace water damaged materials once corrective actions completed.

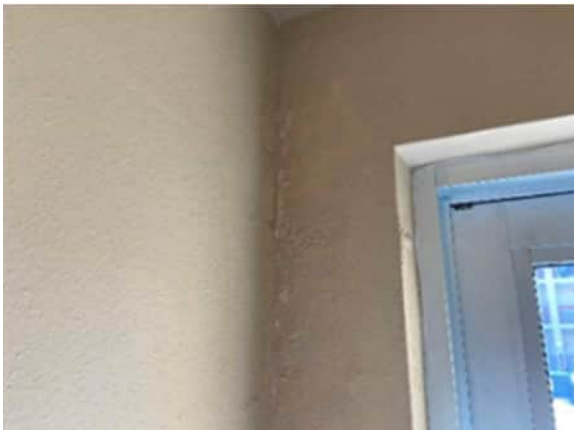
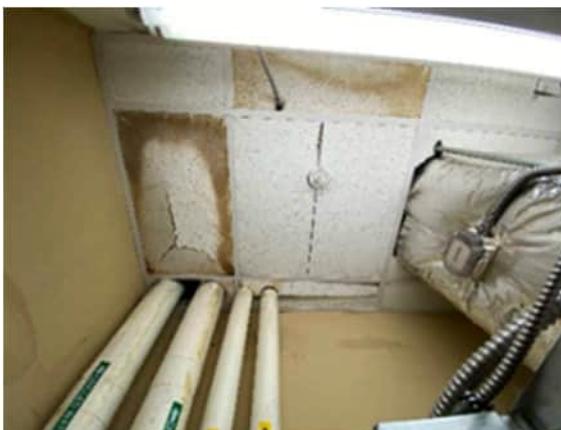
Common Areas:

- Moisture damaged building materials on perimeter wall near exit in 1st FL Common area
- Moisture damaged building materials on dropped ceiling of HVAC Closet in 1st FL Common area

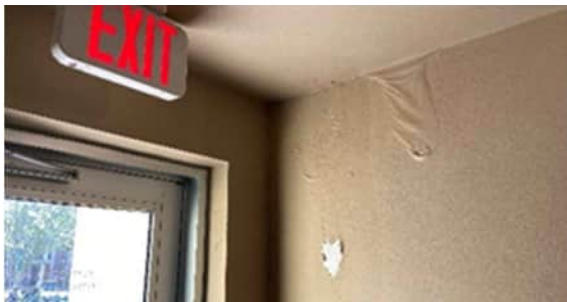
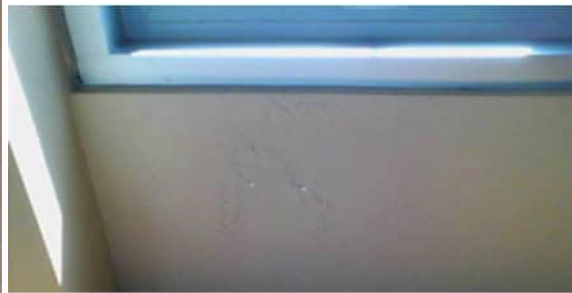
Common Areas:

- Moisture damaged building materials on perimeter wall near exit in 1st FL Common area
- Moisture damaged building materials on wall below east window on stair landing

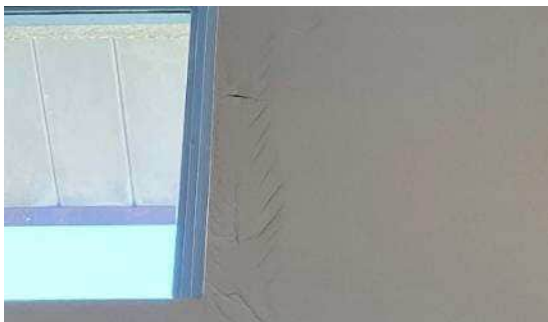
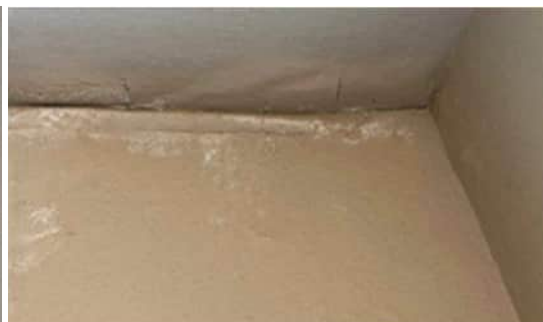
Common Areas:

- Moisture damaged building materials on perimeter wall near exit in 1st FL Common area
- Moisture damaged building materials on wall below window of north wall

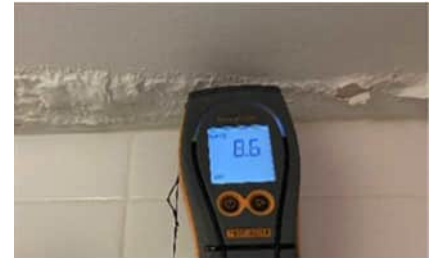
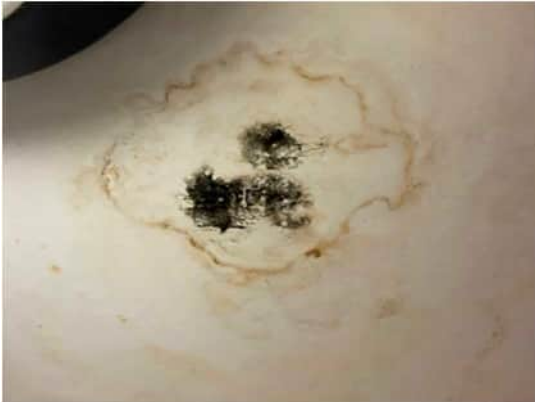
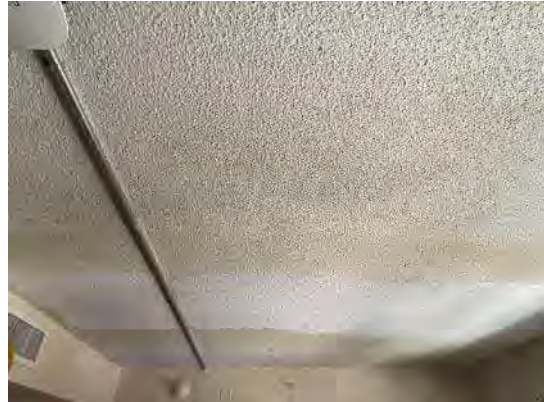
Building Goldstein

Goldstein – Minimal moisture damage observed in the occupied areas assessed. Water-stained ceilings in living areas adjacent to HVAC supply ducts could be contributed to sweating, duct seal failure or temperature differentials via introduced outside air. Visible mold on the ceiling of a unit restroom shower is likely to be a plumbing failure from the unit above.

- Moisture damaged ceiling and wall building materials
- Suspect Visible Mold on ceiling in restroom
- Moderate dust load and Suspect Visible Mold on HVAC vents.
- No building materials were “wet” in units assessed

- ❖ Remove water and/or mold damaged building materials within the restroom and in living areas.
 - Determine the source of the water/moisture and take appropriate corrective actions prior to the replacement of the building materials. Leaving water damaged building materials in place is not recommended due to the fact that mold, even though not visible, is present/dormant and will become active again quickly.

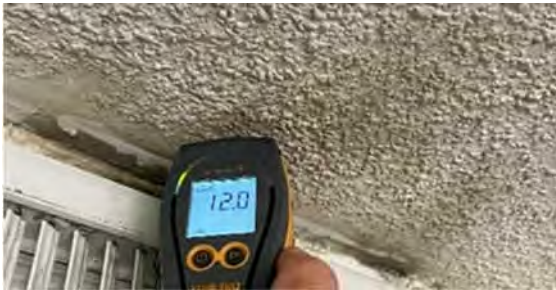
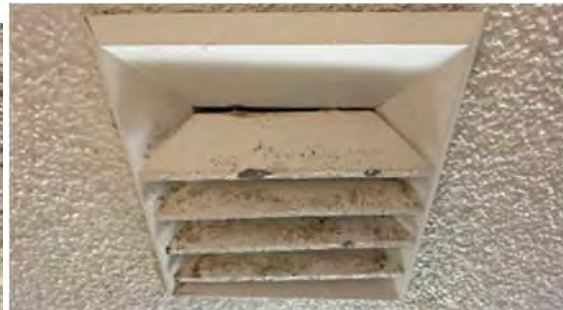
Building Dort

Dort – Minimal moisture damage observed in the occupied areas. The moisture staining on ceilings adjacent to HVAC supply duct vents could be contributed to sweating or seal failure or temperature differentials via introduced outside air.

- Moisture damaged ceiling and wall building materials
- Suspect Visible Mold on ceiling
- Moderate dust load and Suspect Visible Mold on HVAC vents.
- No building materials were “wet” in units assessed

- ❖ Dust and Suspect Visible Mold on supply diffusers can be addressed by housekeeping or maintenance by removing and brush cleaning with a soapy water. Use of rubber or foam seal between metal diffuser and ceiling or wall material will reduce the potential for moisture/water damage and SVM.
- ❖ Moisture damaged areas could be addressed by maintenance personnel and prevented through routine maintenance.
