TARGETED MOISTURE AND MOLD ASSESSMENT REPORT

New College Residential Buildings PEI 2 and PEI 3

5800 Bay Shore Road
Sarasota, Florida 34243

August 16, 2023

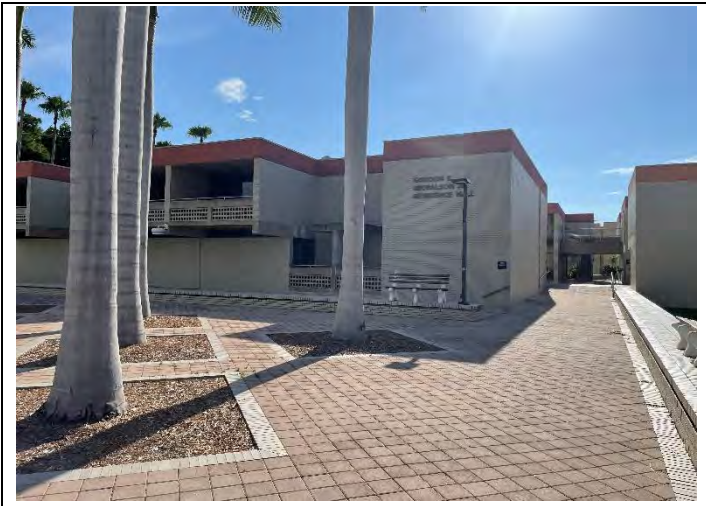
1. View of PEI 2 Building (exterior)

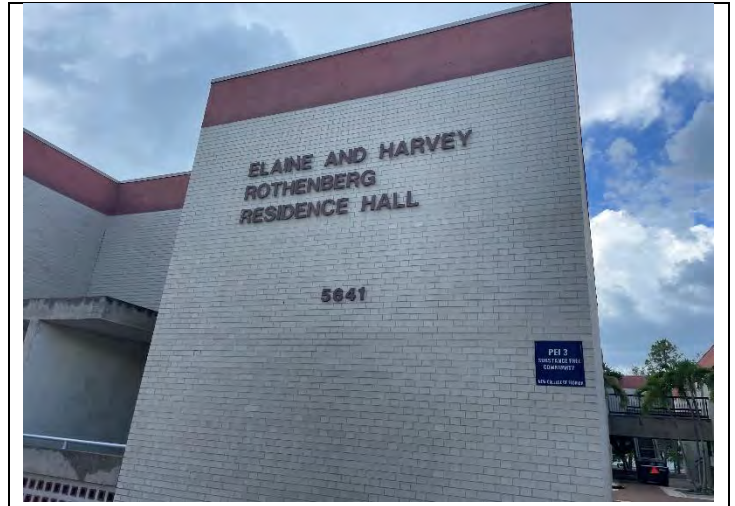
2. View of PEI 3 Building (exterior)

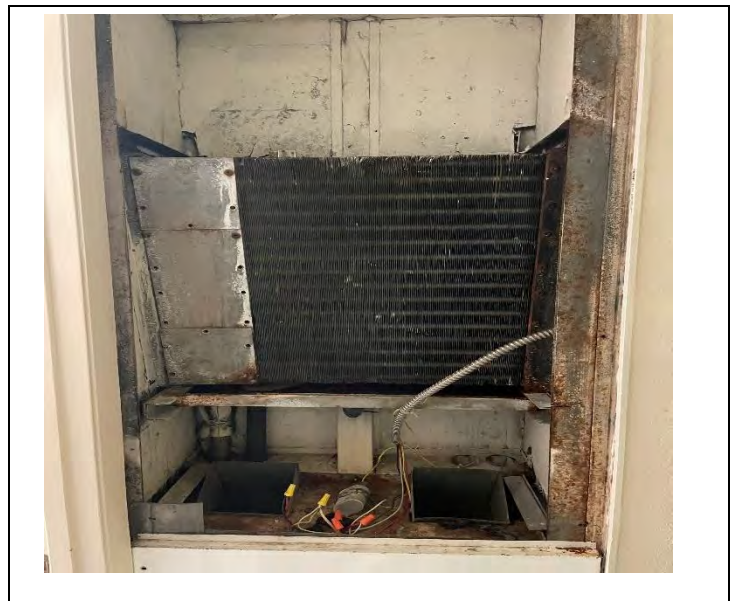
Aged, dusty, and rusted HVAC units were observed in all of the assessed units. Some were observed to have mis-aligned condensation drain pans causing moisture damage to surrounding building materials. The system observed in unit 315 was observed to have surficial SVG present on the unit housing and various components on the interior of the unit. Return chambers in some systems were observed to have standing debris visible. An HVAC filter in the system of unit 204 was observed to be saturated with condensation. The HVAC units were functioning, but possibly not operating effectively or efficiently due to their observed conditions.

6. Interior view of a typical HVAC unit observed in all units

- ❖ Create a general maintenance checklist to include routine inspections for water/SVG damage, replacement of a/c filters, inspection of interior components of HVAC unit (including alignment of drip pans), inspection of HVAC supply vents/diffusers for cleanliness, similarly to how Partner conducted this Assessment.

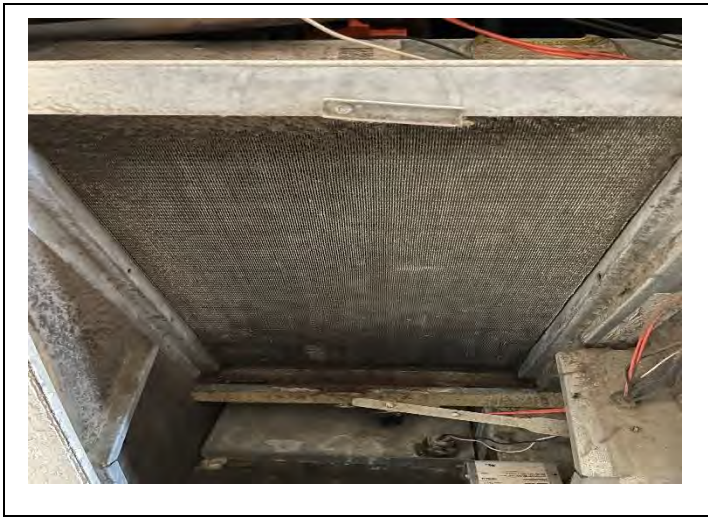
7. Interior view of typical HVAC coil observed in all units

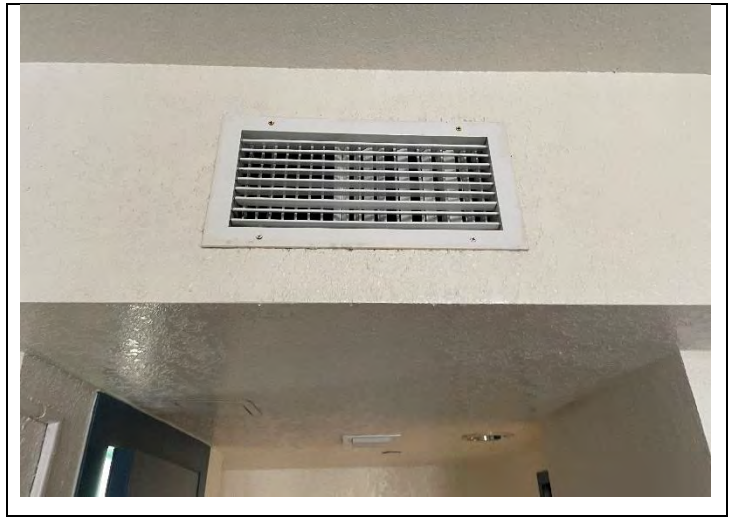
8. View of condensate on supply diffuser in PEI 216

- Use of a rubber seal between metal supply vents/diffusers and building material may control water/SVG damage on the walls, ceilings or ceiling panels.

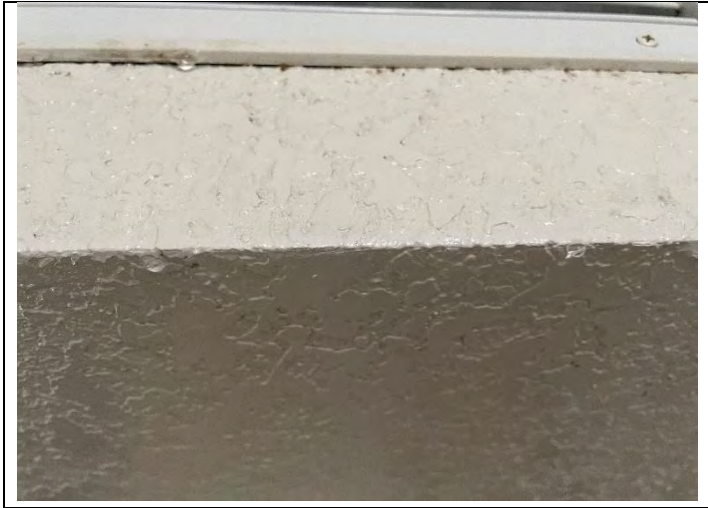
9. Close up view of condensate on supply diffuser in PEI 216

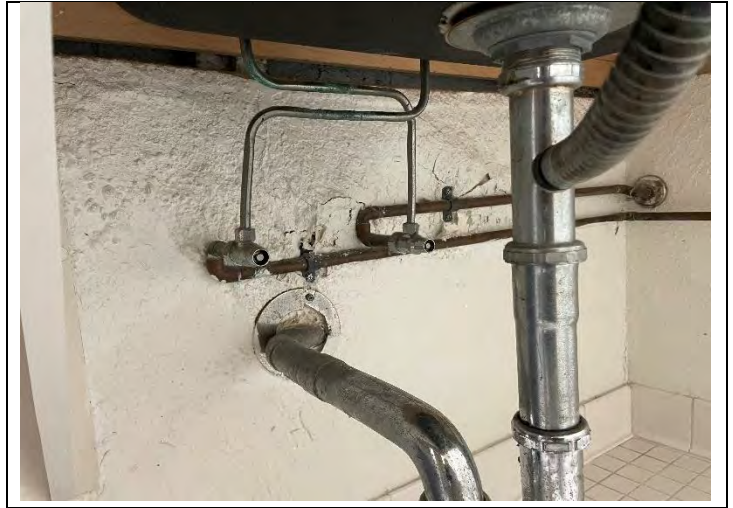
10. View of long term water damage and efflorescence on wall under restroom sink in PEI 205

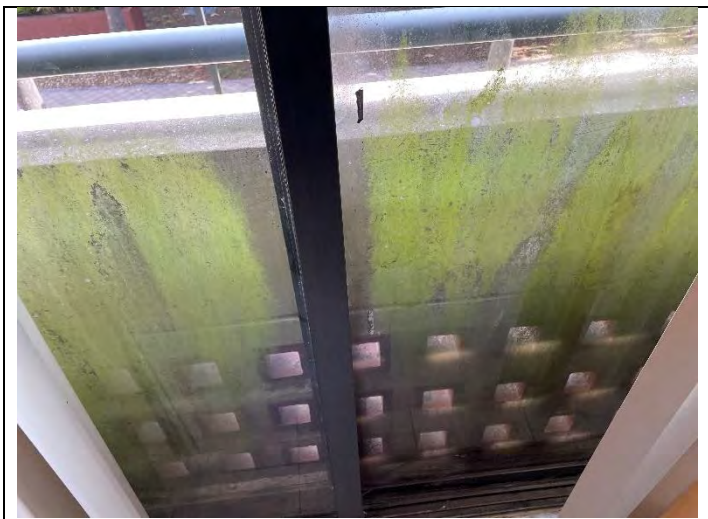
11. View of typical water exposure and algae buildup on exterior sliding door in PEI 212

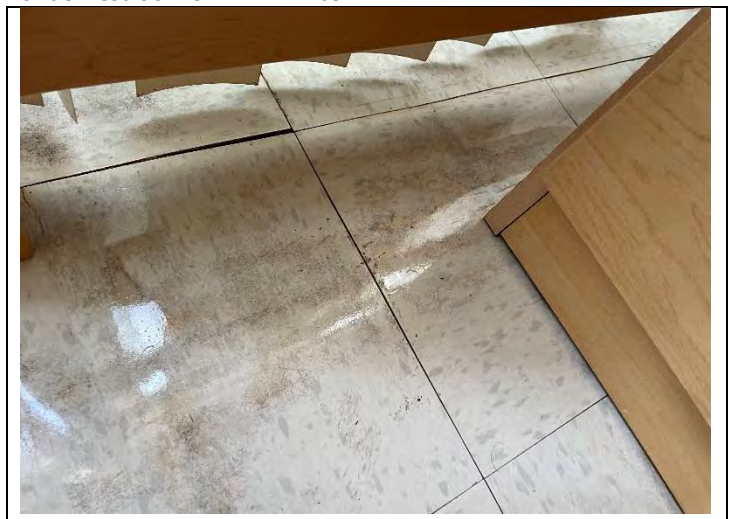
12. View of water damaged floor tiles adjacent to sliding balcony door in PEI 212

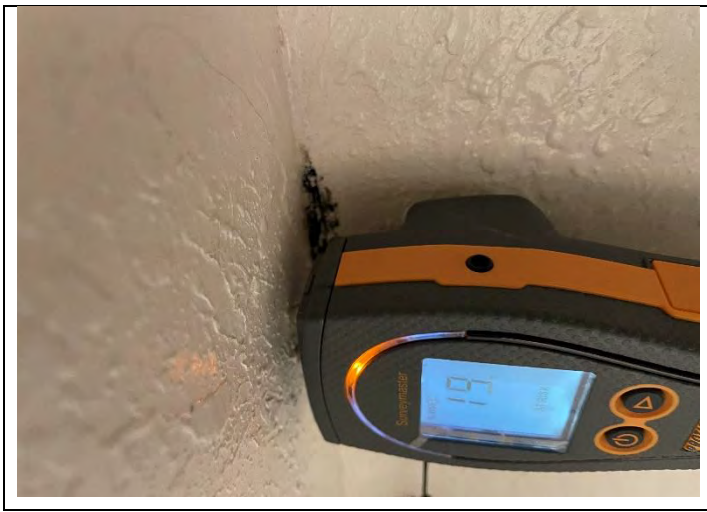
13. View of SVG and elevated moisture levels using Protimeter under restroom sink in PEI 221

- ❖ Immediate response to surficial SVG on building materials and SVG on moisture-damaged building materials should be addressed by either removing and replacing the material or cleaning with soapy water scrubbing, depending on the scenario encountered.

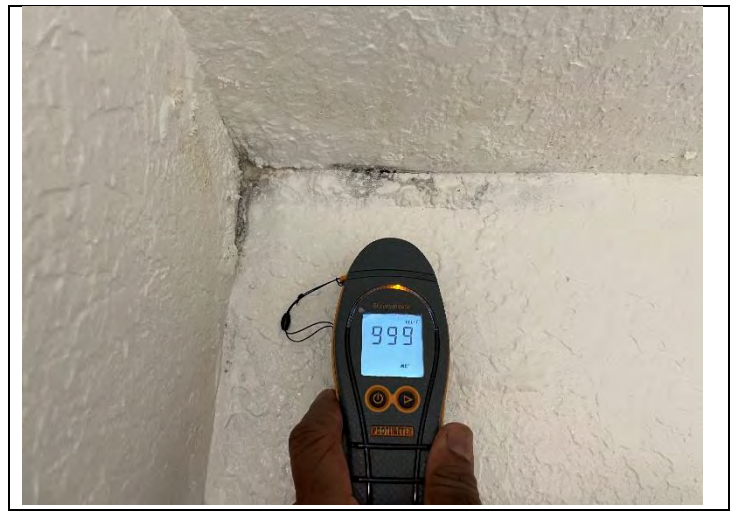
14. View of SVG and elevated moisture levels using Protimeter on restroom ceiling PEI 223

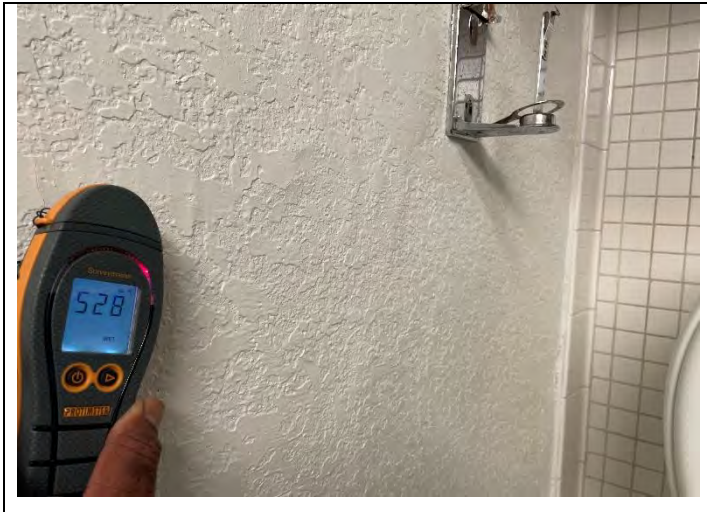
15. View of elevated moisture levels using Protimeter in restroom of PEI 227

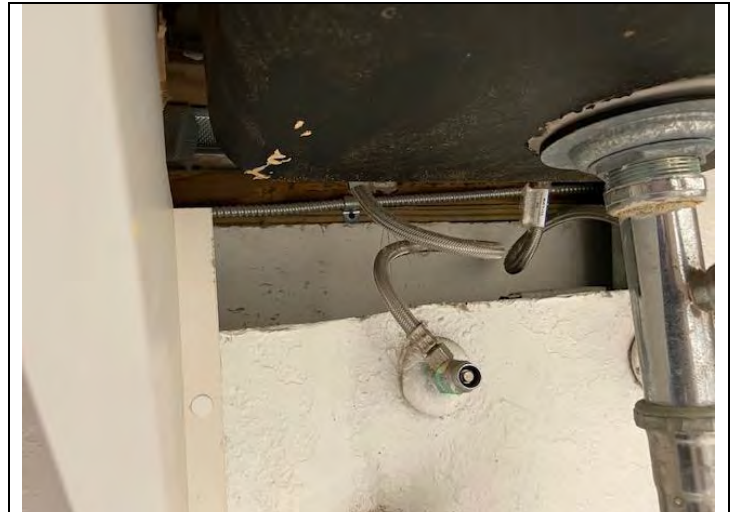
16. View of SVG under sink in PEI 232

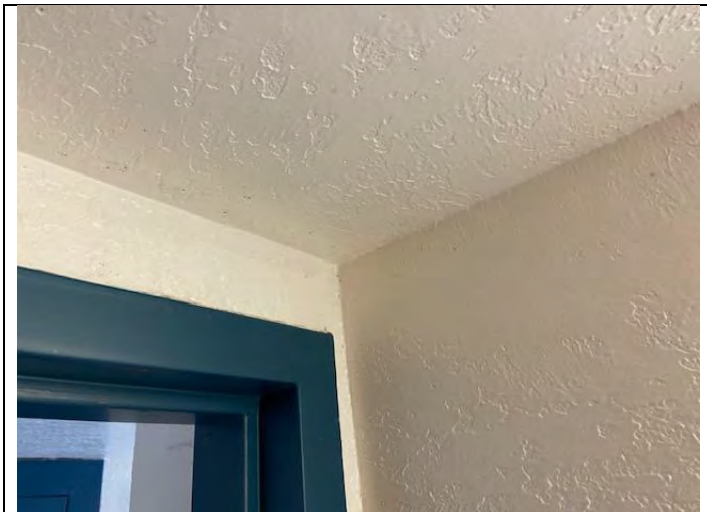
17. View of SVG on unit ceiling (outside restroom) of PEI 232

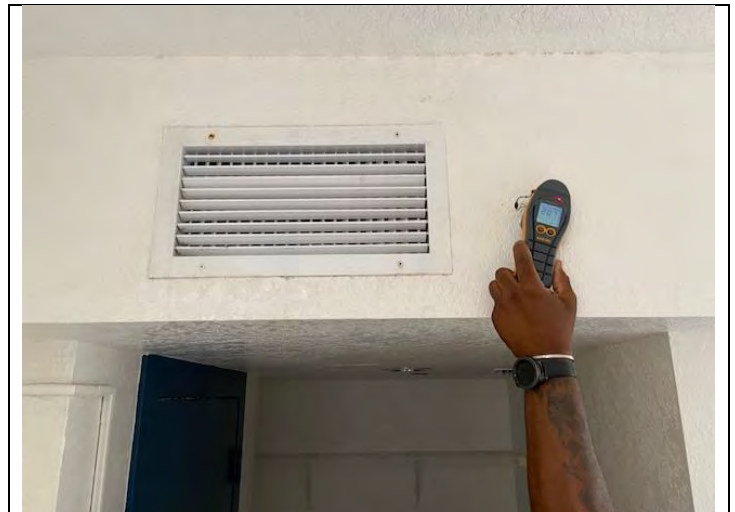
18. View of elevated moisture levels using Protimeter around supply diffuser in PEI 230

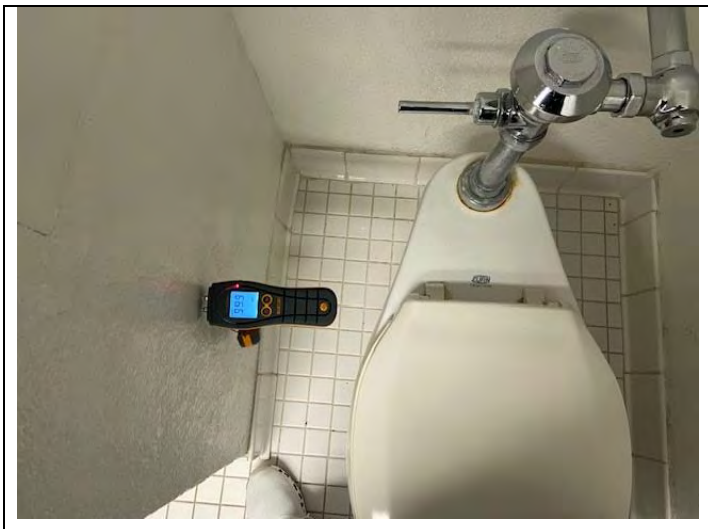
19. View of elevated moisture levels using Protimeter on wall material surrounding toilet in PEI 238 (similarly found in PEI 227, 225, 236, 241, 242)

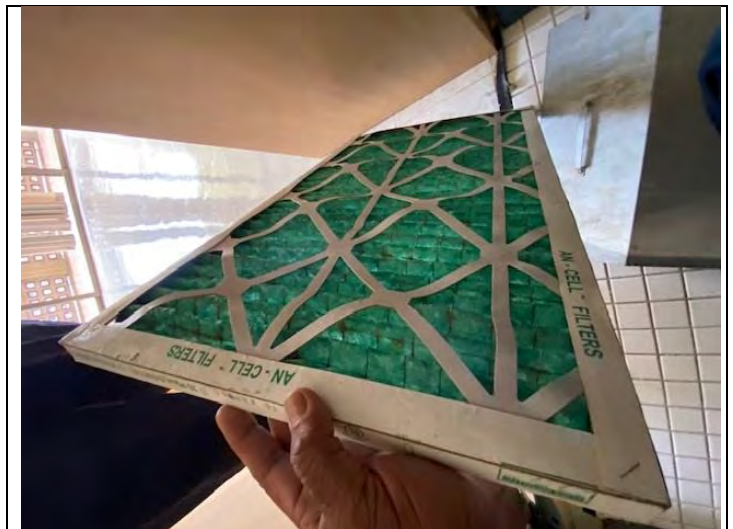
20. View of saturated HVAC filter found in PEI 240

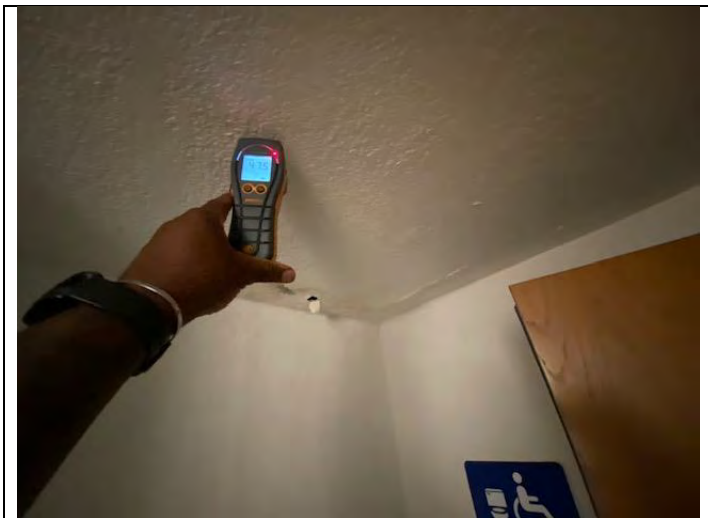
21. View of SVG with elevated moisture levels using a Protimeter on ceiling outside restroom in PEI 2 Lounge

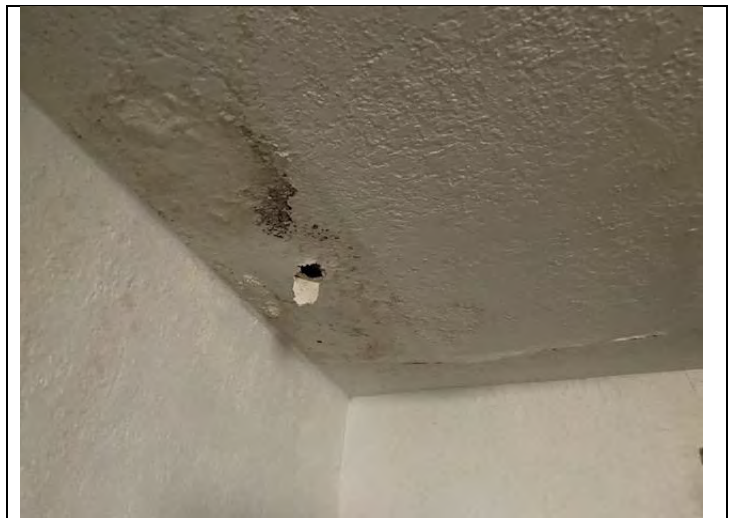
22. Close up view of SVG on ceiling outside restroom in PEI 2 Lounge

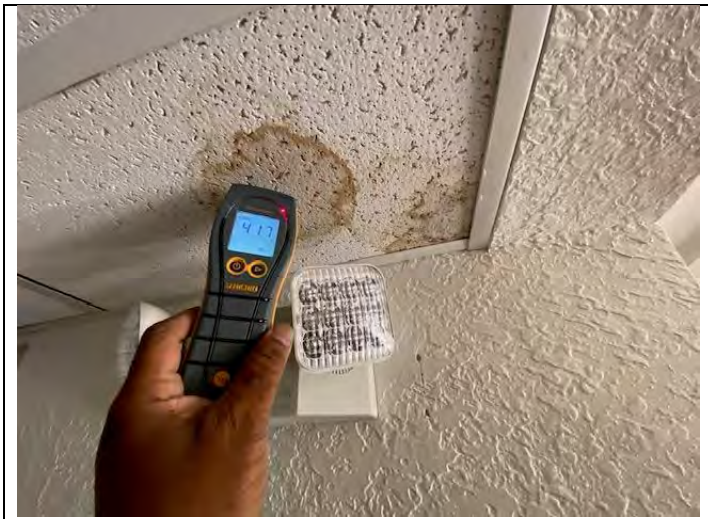
23. View of water damaged ceiling tile with elevated moisture levels using Protimeter in PEI 2 Lounge kitchen

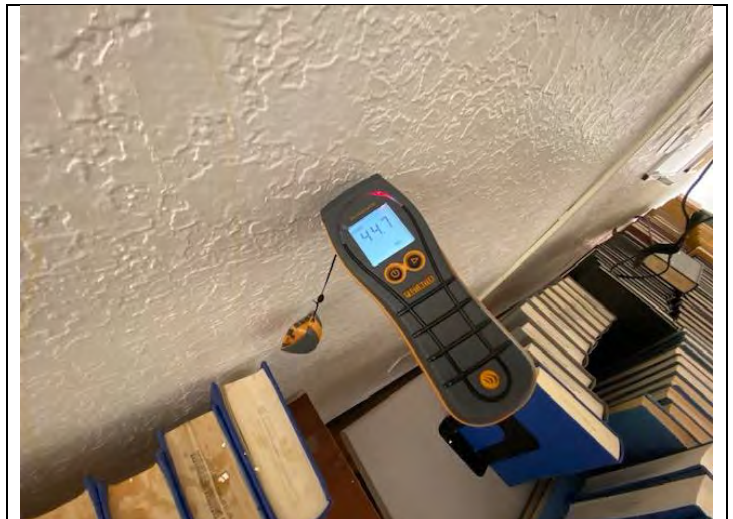
24. View of elevated moisture using Protimeter on south wall in PEI 2 Lounge

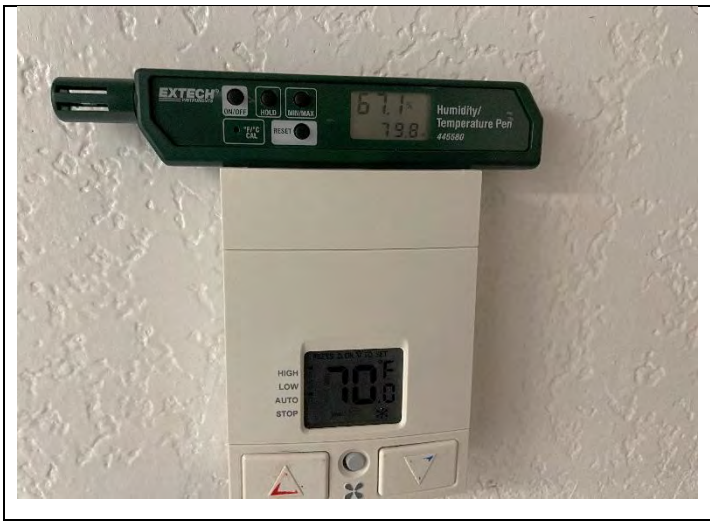
25. View of thermostat set point compared to temperature/RH pen comparison

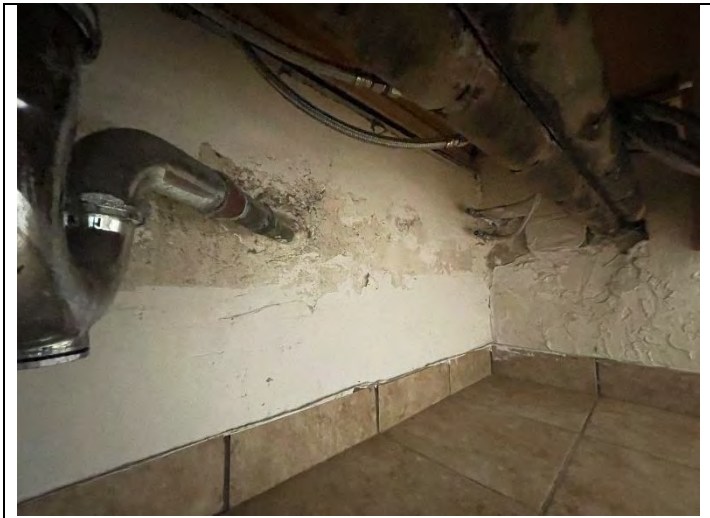
29. View of moisture damage under restroom sink in PEI 305

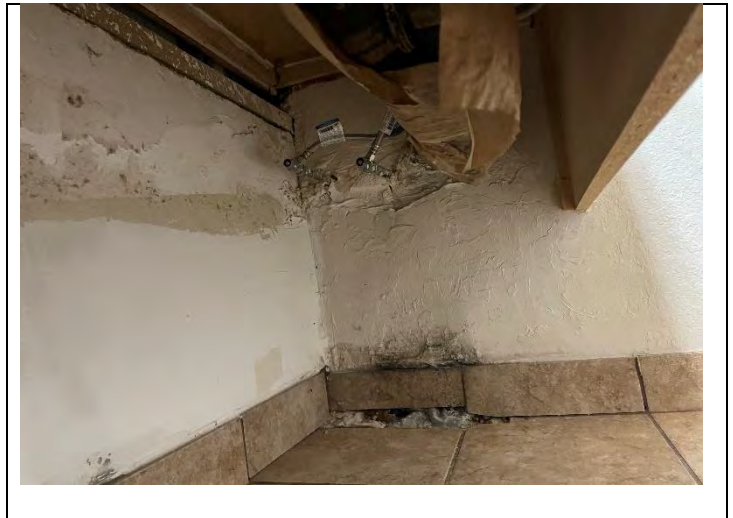
30. View of SVG and moisture damage under restroom sink in PEI 307

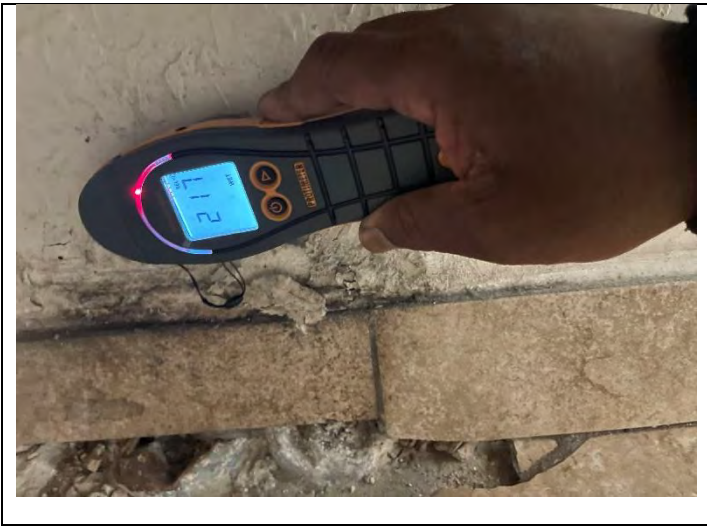
31. View of SVG and elevated moisture using Protimeter under restroom sink in PEI 307

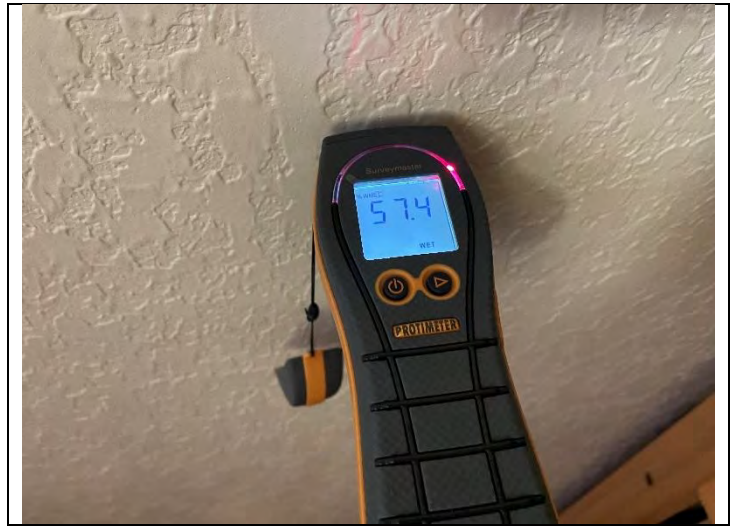
32. View of elevated moisture in ceiling and wall material around HVAC system in PEI 307

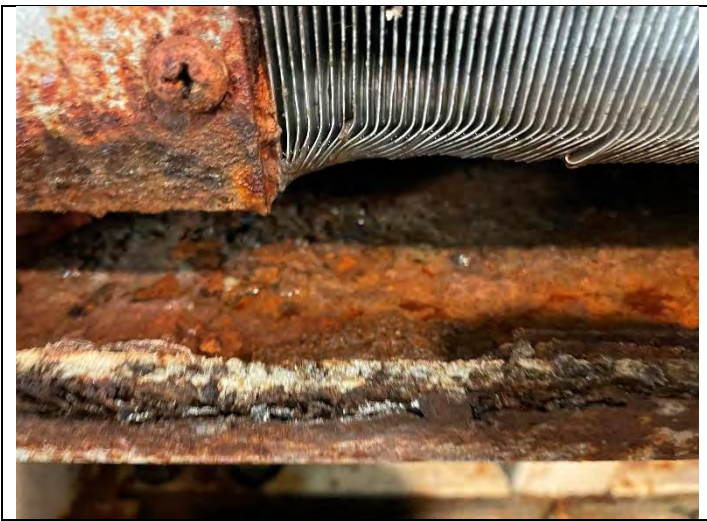
33. View of rusted HVAC drip pan in PEI 307

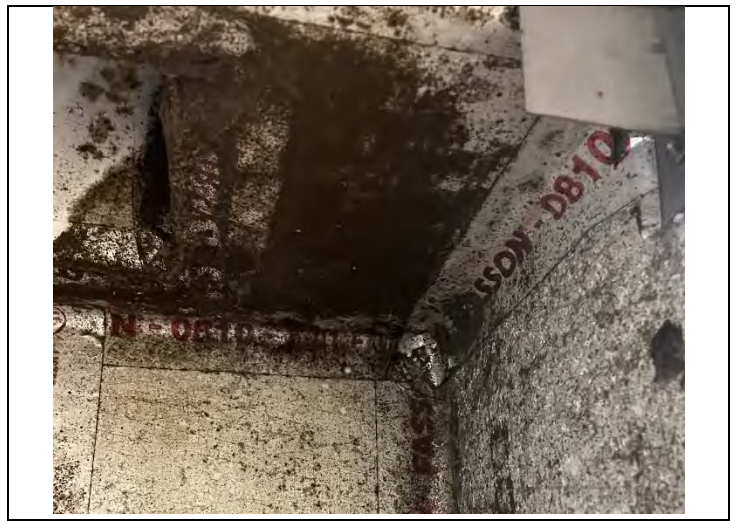
34. View of SVG on top right corner of HVAC system in PEI 315

- ❖ The identified surficial SVG inside the interior of the HVAC unit within unit 315 should be cleaned by a Florida licensed mold remediation contractor. It is also recommended to utilize the same approach for any other AHUs encountered where similar conditions are identified.

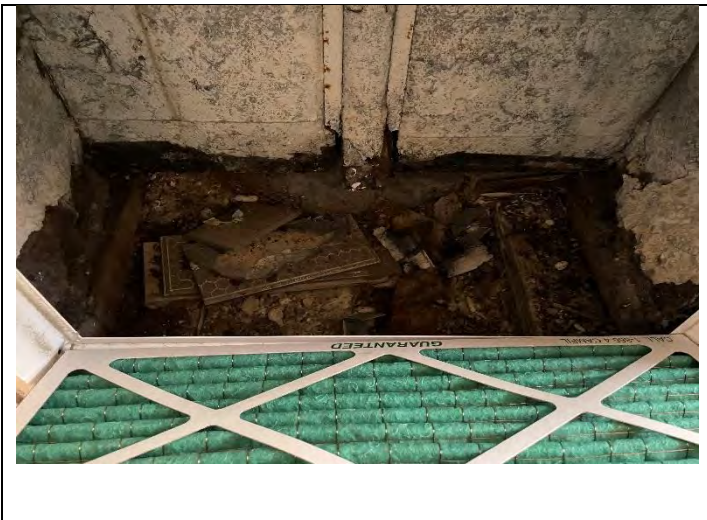
35. View of broken HVAC return box with visible debris in PEI 317

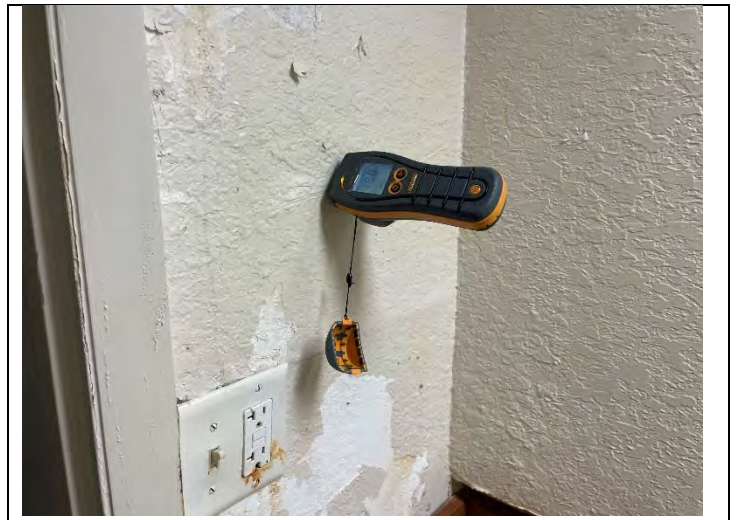
36. View of water damage and elevated moisture levels using Protimeter in restroom walls of PEI 345

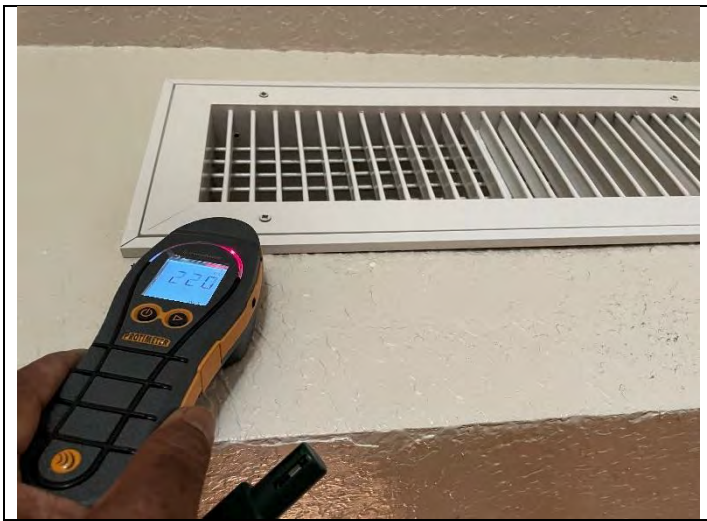
37. View of elevated moisture levels using Protimeter around supply diffuser in PEI 345

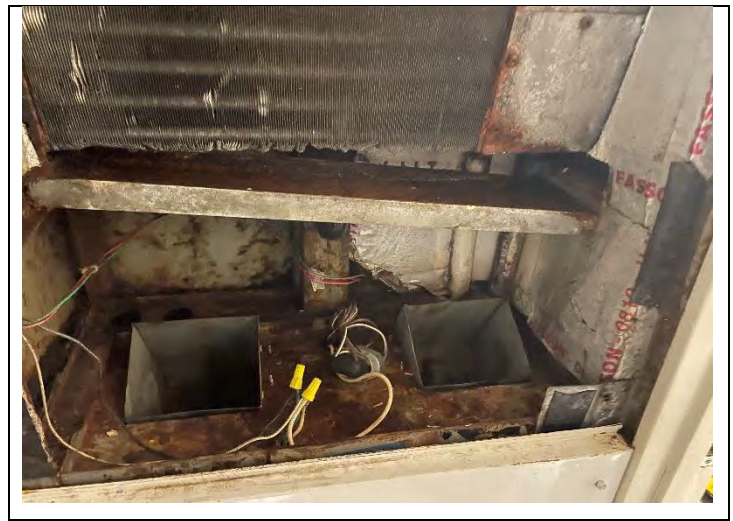
38. View of damaged condensate pan support, draining to wall in PEI 345

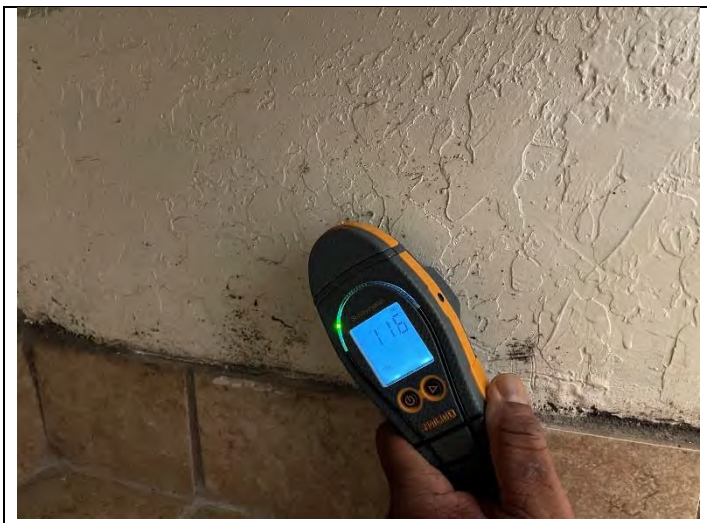
39. View of SVG with dry moisture level with Protimeter under restroom sink in PEI 331

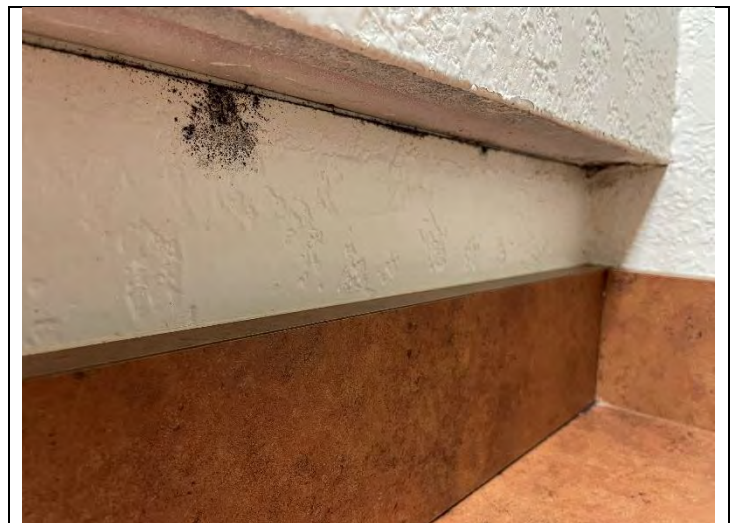
40. View of SVG under restroom mirror PEI 331

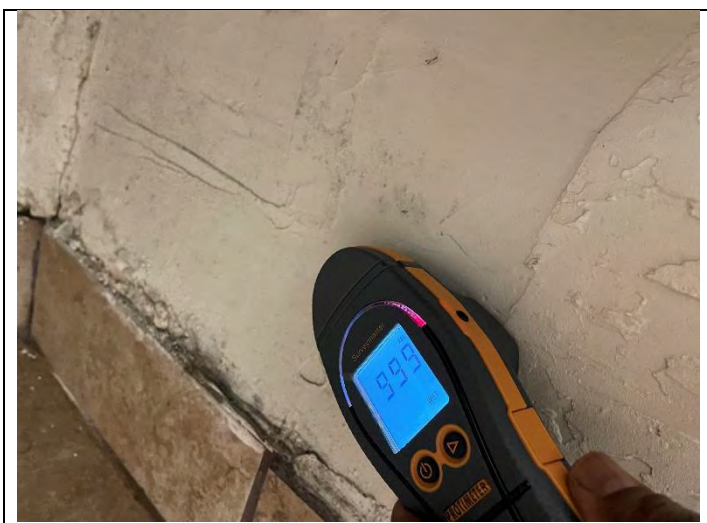
41. View of SVG and elevated moisture level with Protimeter under restroom sink in PEI 308

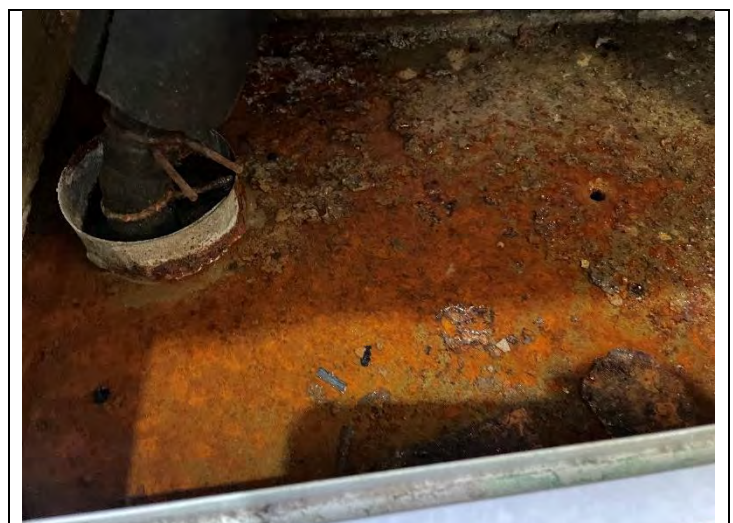
42. View of standing water in HVAC return box likely caused by drip pan out of alignment

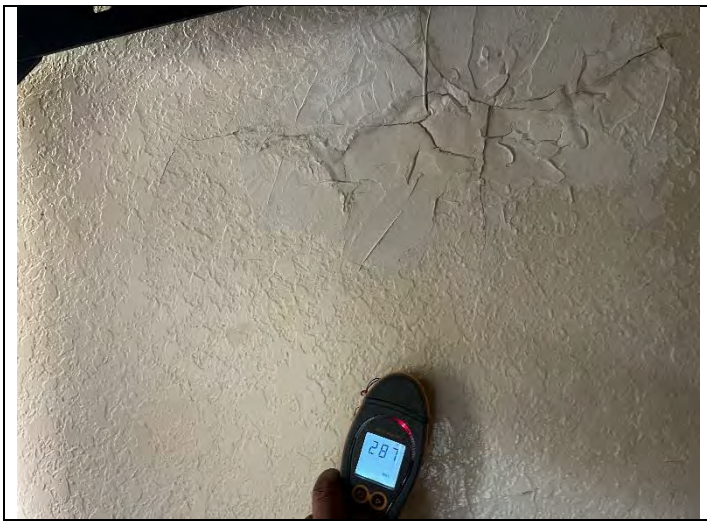
43. View of moisture damage and elevated moisture with Protimeter on North wall in PEI 342

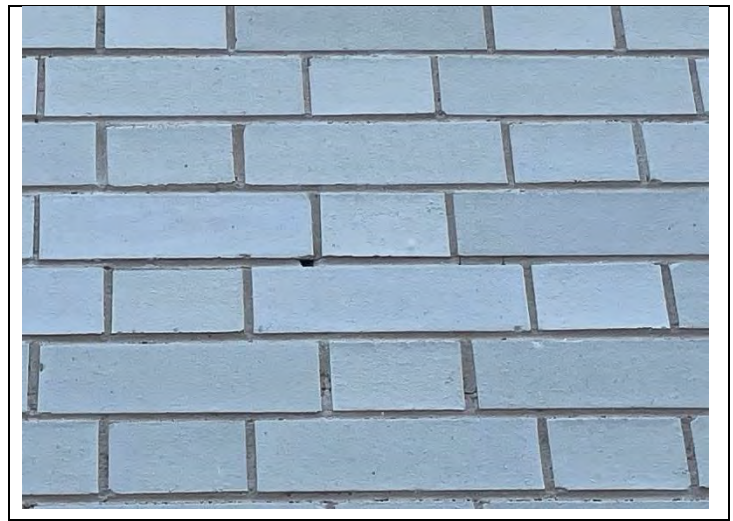
44. View of typical exterior PEI 2 and 3 buildings with identified holes in grout.

- ❖ Due to observed cracking in exterior brick façade, spalling concrete on building walls, balconies and stairs, and damaged floor tile & grout on balconies, conduct an envelope evaluation to resolve moisture intrusion areas of the PEI 2 and PEI 3 buildings. Recurrent moisture intrusion will lead to recurrent SVG.

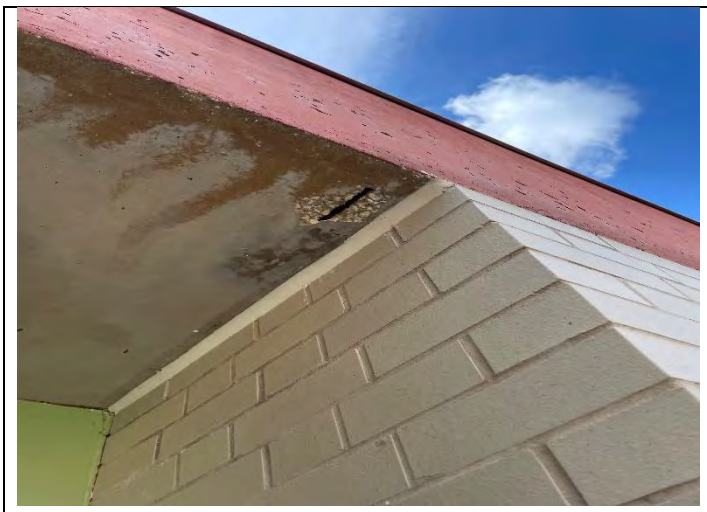
45. View of typical exterior PEI 2 and 3 buildings with visible water damage and spalling of concrete

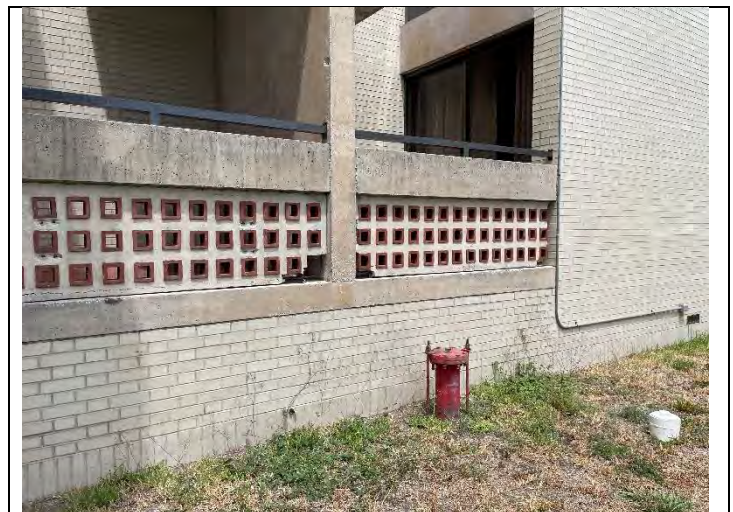
46. View of typical balcony for PEI 2 and 3 buildings with visible brick damage

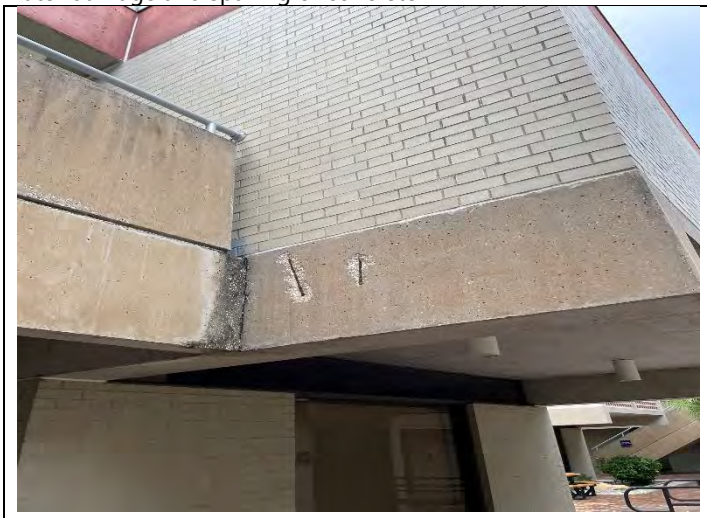
47. View of typical exterior PEI 2 and 3 buildings with visible water damage and spalling of concrete.
